# ASBESTOS MANAGEMENT SURVEY

Glynneath Town Hall Heathfield Avenue Glynneath Neath SA11 5AH

7 May 2024

ALL107396/24/JA-1

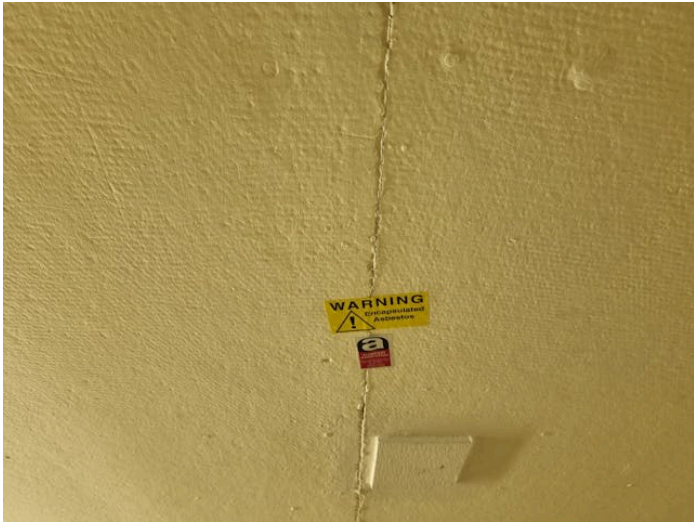
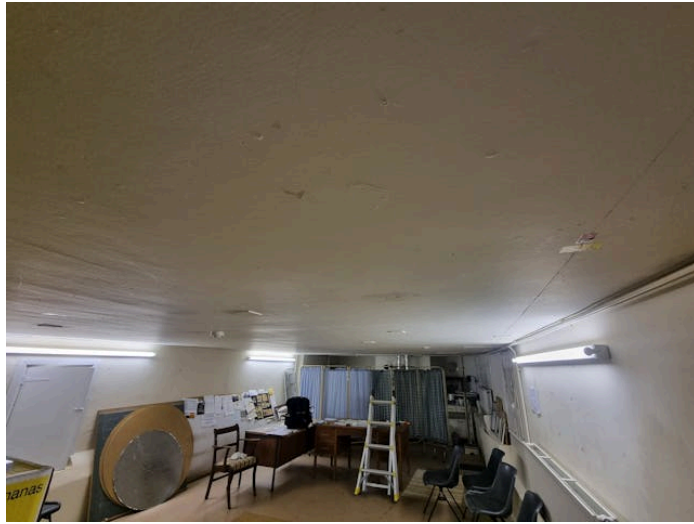
## Main Building > -1 > 01 - First Aid Room > Ceiling

**Insulating Board Ceiling within rooms -1/01 & -1/02.** We recommend for these materials to be encapsulated and managed in-situ. **These materials contain Amosite asbestos.**

| Material | Insulating Board | Extent | Approximately 32 m <sup>2</sup> |
| Strategy / Sample Id | Sample / 107396/01 | Fibre Type | Amosite |

| Material Score | 6 / Low | | |

| Recommendation | Encapsulate and Manage | | |

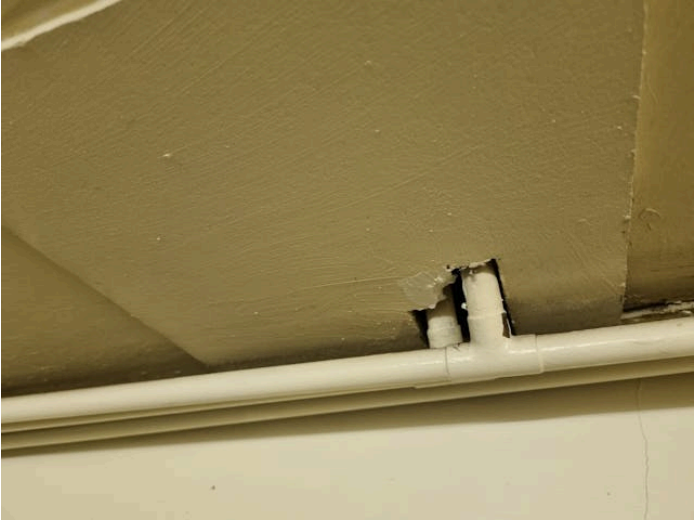
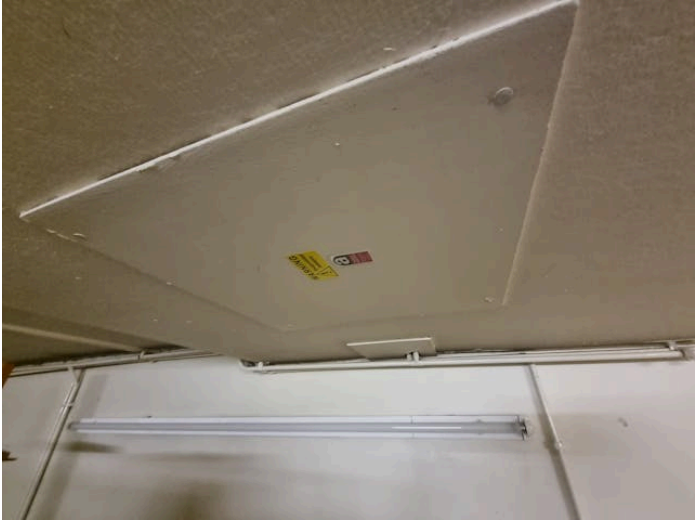
Main Building > -1 > 01 - First Aid Room > Ceiling

| Material | Insulating Board Panels | Extent | Approximately 1 m² Sporadic |
| Strategy / Sample Id | Sample / 107396/02 | Fibre Type | NADIS |

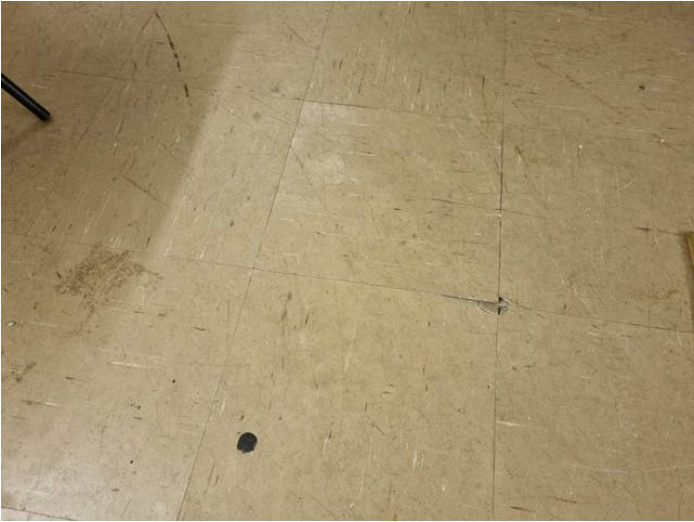
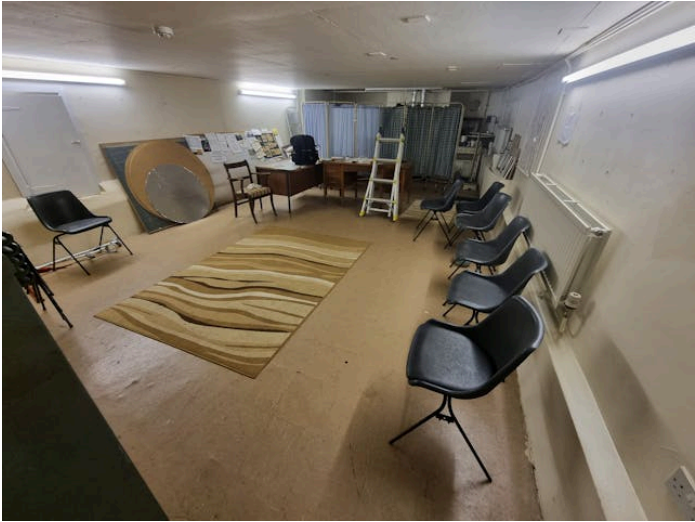
Main Building > -1 > 01 - First Aid Room > Floor

| Material | Pink Thermoplastic Floor Tiles | Extent | Approximately 32 m² |
| Strategy / Sample Id | Sample / 107396/03 | Fibre Type | NADIS |

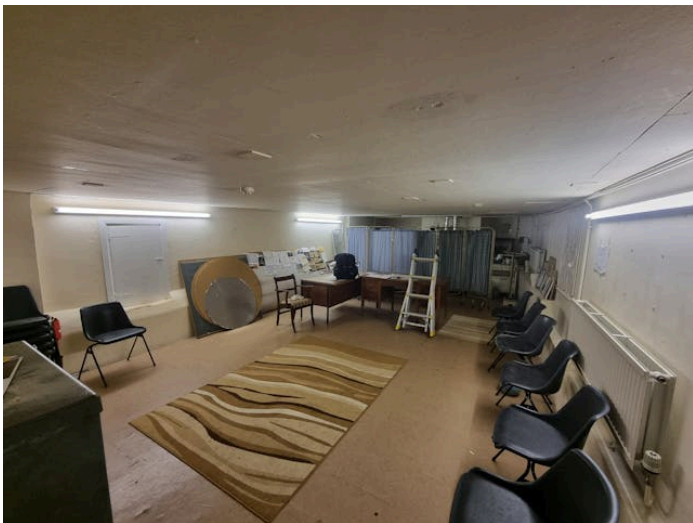
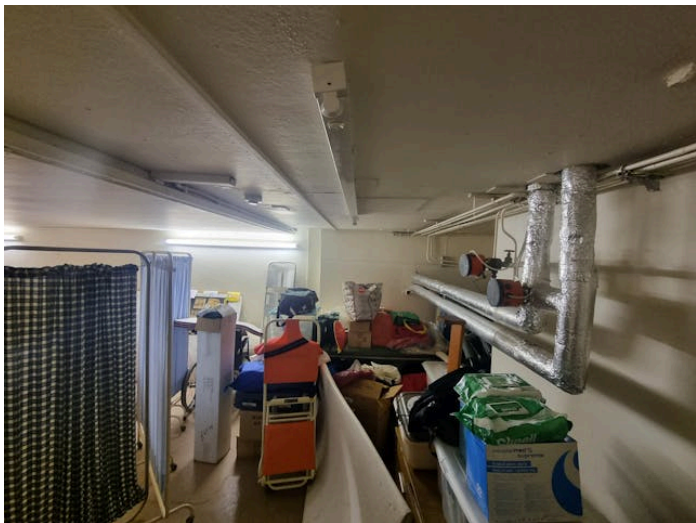
Main Building > -1 > 01 - First Aid Room > Location Notes

| Location Notes | Insulating board ceiling, wooden framework, plasterboard and masonry walls, thermoplastic floor tiles to concrete floor, insulating board panels to damaged section of of ceiling, foil wrapped MMMF lagged metal pipework, wood panels to sections of masonry walls, unlagged copper pipework, large amount of stored items. | | |

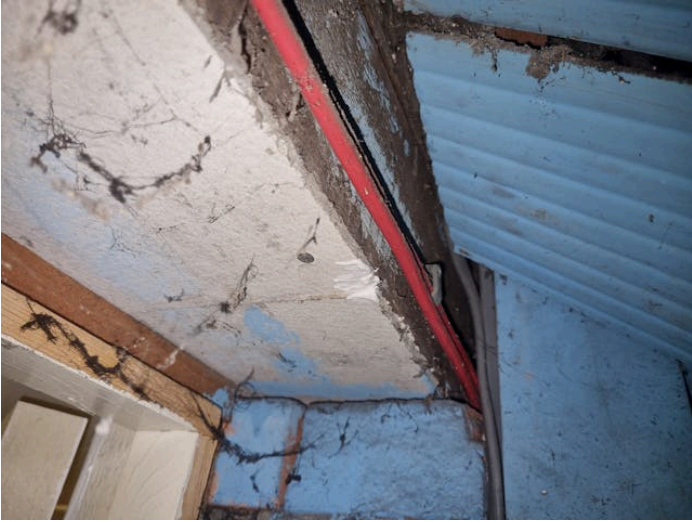
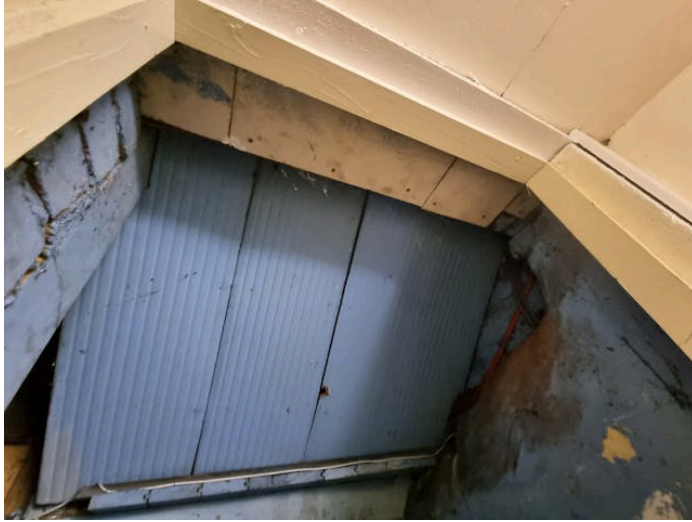
## Main Building > -1 > 02 - Understair Cupboard > Ceiling

| Material | Insulating Board | Extent | Small Amount |
| Strategy / Sample Id | Sample / 107396/04 | Fibre Type | Amosite |

| Material Score | 7 / Medium | | |

| Recommendation | Encapsulate and Manage | | |

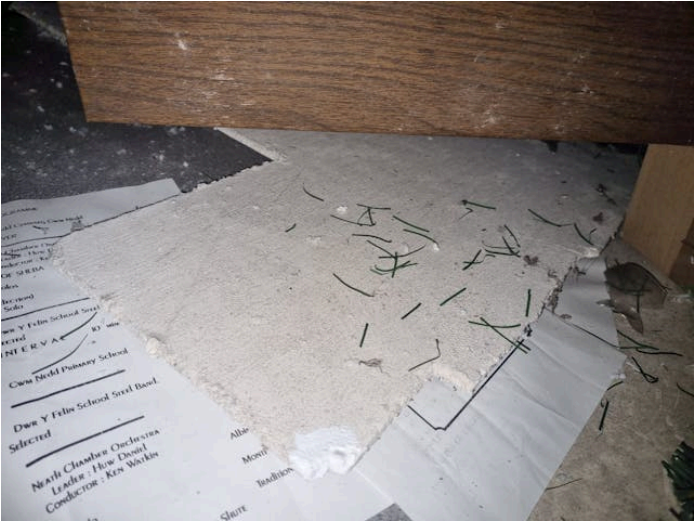
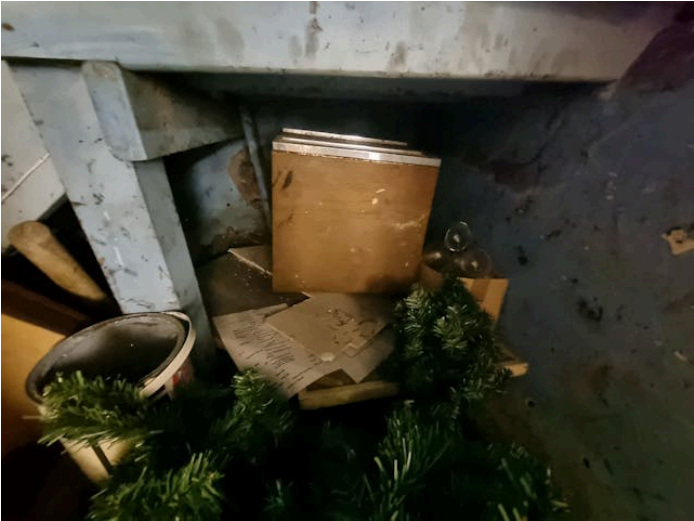
Main Building > -1 > 02 - Understair Cupboard > Redundant Insulating Board Panel

| Material | Insulating Board | Extent | 0.5 m <sup>2</sup> |
| Strategy / Sample Id | Sample / 107396/05 | Fibre Type | NADIS |

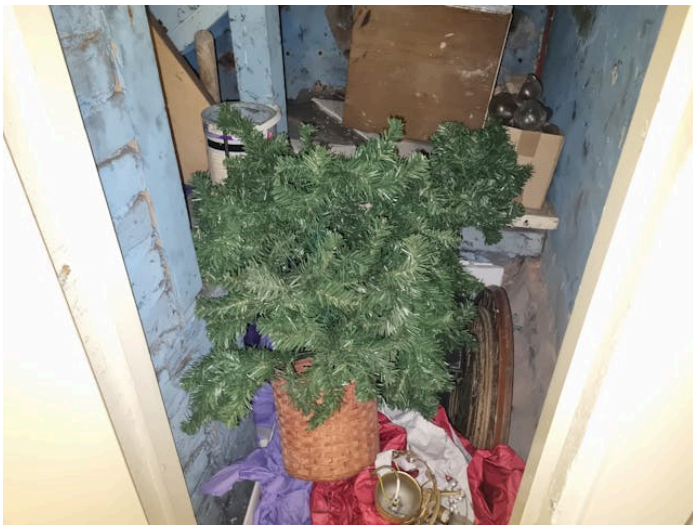
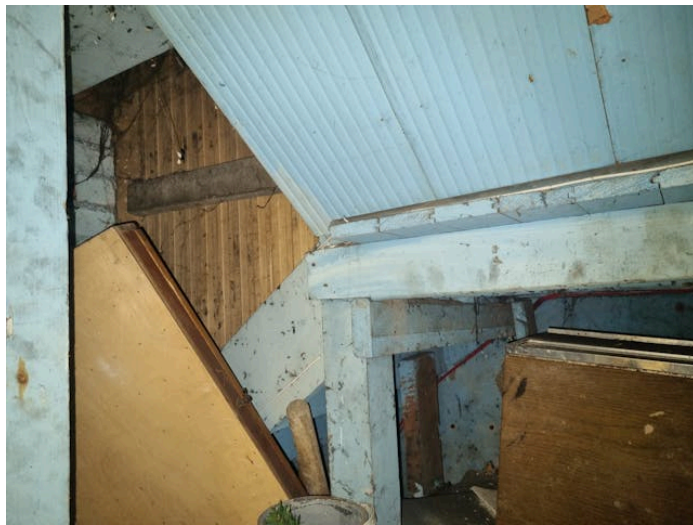
## Main Building > -1 > 02 - Understair Cupboard > Location Notes

| Location Notes | Insulating board (unsealed) continuing from room -1/01 ceiling, section of boarded wooden ceiling, fibreboard understair panels, wood and masonry walls, concrete floor, redundant insulating board panel, large amount of stored items. | | |
| Access / Notes | Limited Access / Large Amount Of Stored Items. | | |

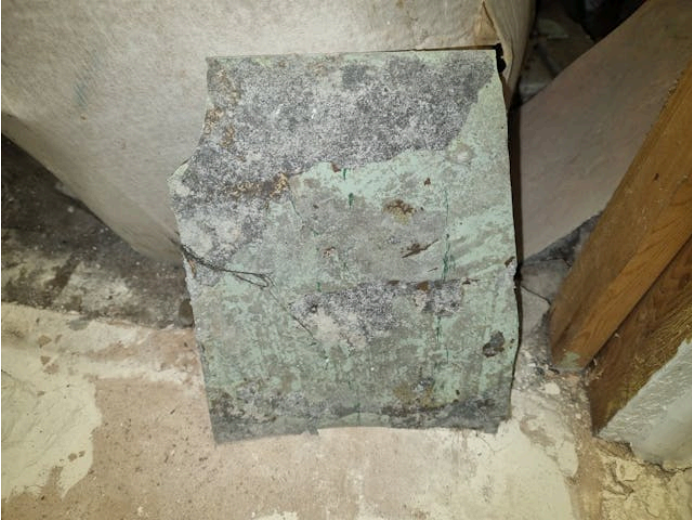
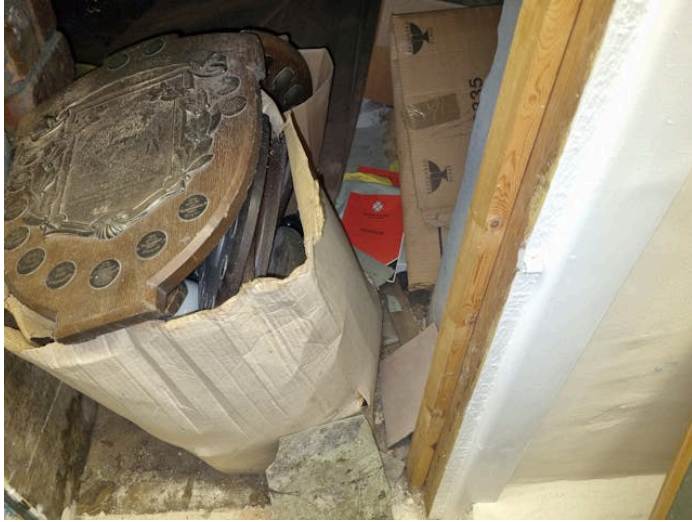
## Main Building > -1 > 03 - Under-Stage > Green Redundant Floor Tiles

**Green Redundant Thermoplastic Floor Tiles found in room -1/03.** A small amount of redundant floor tiles out loose within the under-stage. We recommend for these to be removed and disposed of as asbestos waste by suitably trained persons. **This materials contains Chrysotile asbestos.**

| Material | Thermoplastic Floor Tiles | Extent | 0.5 m <sup>2</sup> Visible |
| Strategy / Sample Id | Sample / 107396/06 | Fibre Type | Chrysotile |

| Material Score | 3 / Very Low | | |

| Recommendation | Remove | | |

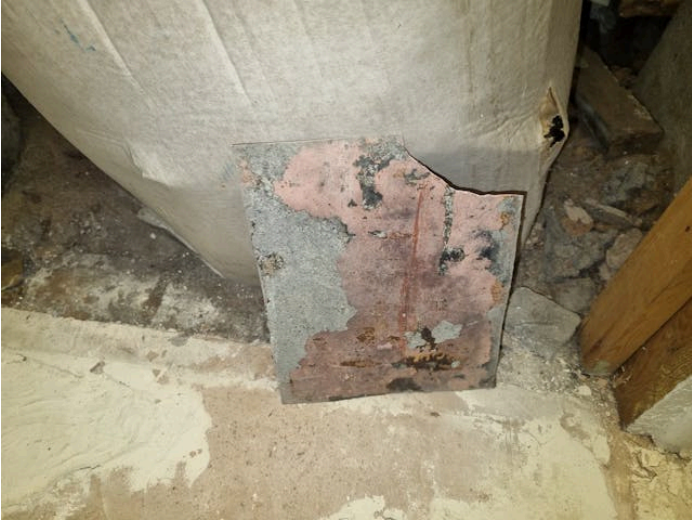
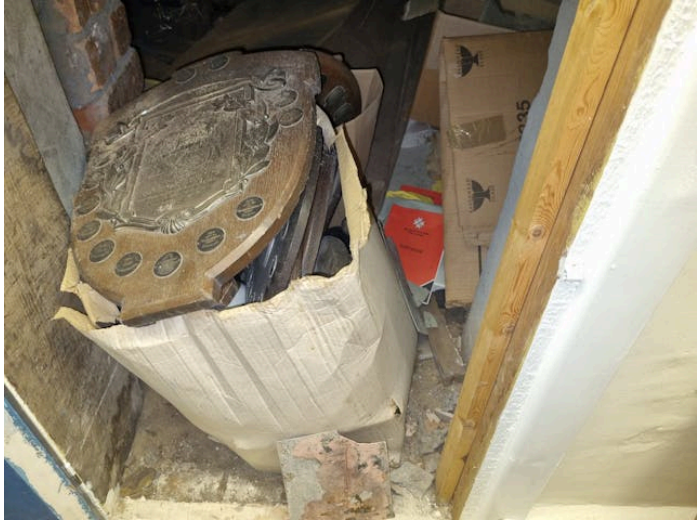
## Main Building > -1 > 03 - Under-Stage > Pink Redundant Floor Tiles

| Material | Thermoplastic Floor Tiles | Extent | 1 Tiles Visible |
| Strategy / Sample Id | Strongly Presume / 107396/07 | Presumed Fibre Type | NADIS |
| General Comments | Visually Similar To 107396/03. | | |

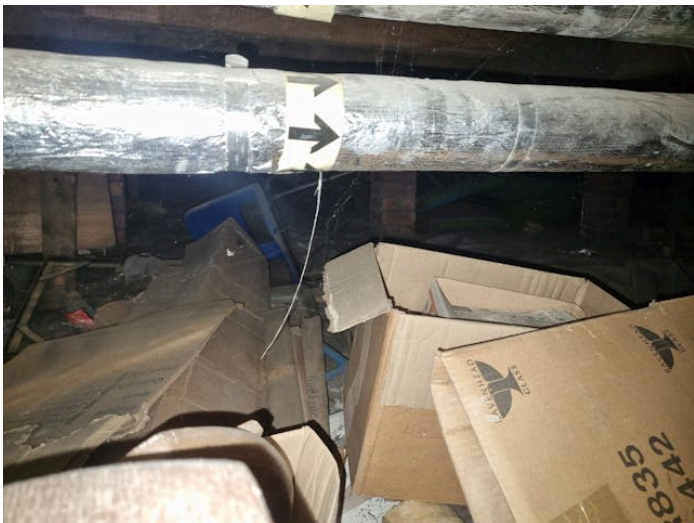
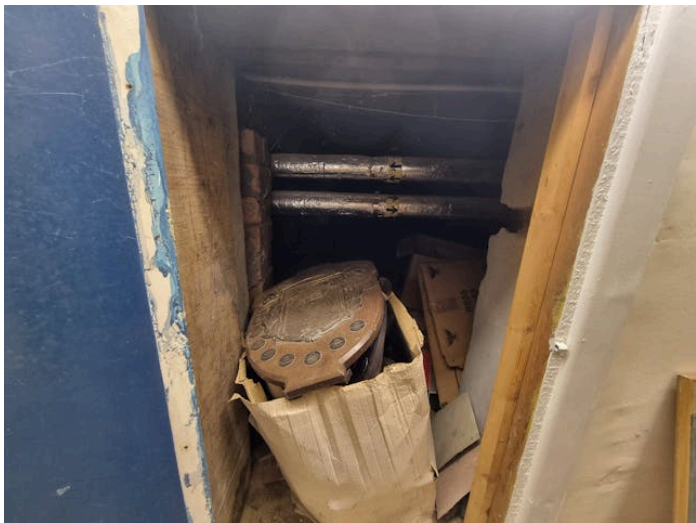
Main Building > -1 > 03 - Under-Stage > Location Notes

| Location Notes | Wooden ceiling, wooden framework, concrete floor, foil wrapped MMMF lagged metal pipework, redundant floor tiles, large amount of stored items. | | |
| Access / Notes | Limited Access / Space Constraints & Large Amount Of Stored Items. | | |
