# Feasibility Assessment Report on Existing Sports Pitches

Welfare Park

Glynneath Town Council

Rev 1

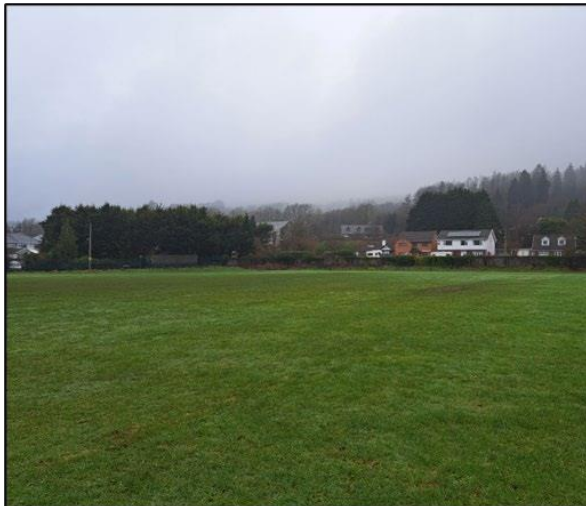
*Figure 2 General view looking north*

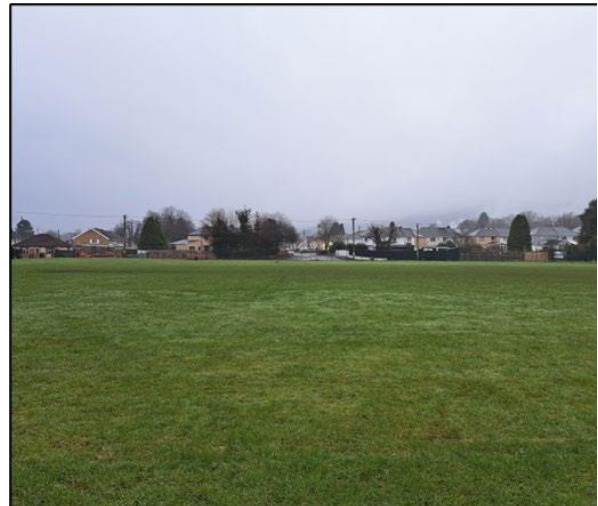
*Figure 3 General view looking west.*

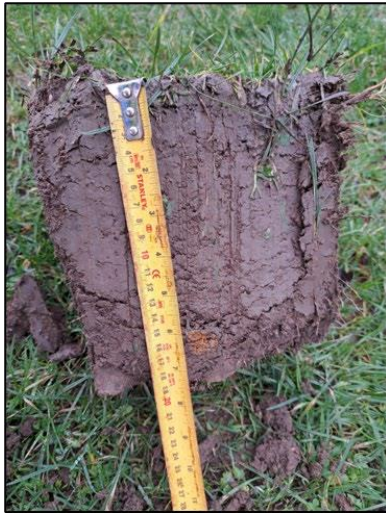
Tests across the site showed the depth of topsoil is 180 mm to 230 mm over a stony clay loam subsoil. There were no signs of layering within the profile. Water on the surface is caused by

the surface de-structuring reduced and slowing water movement, the surface of the profile has a 20 mm layer of thatch (organic matter) which will slightly affect water movement.

Figure 5 Soil profile –rugby pitch

To correct this situation, consideration should be given to the installation of a surface by-pass drainage system. These systems work by intercepting rainwater at the surface before it has had an opportunity to soak into the soil profile, and then removing this water to a system of piped drains.

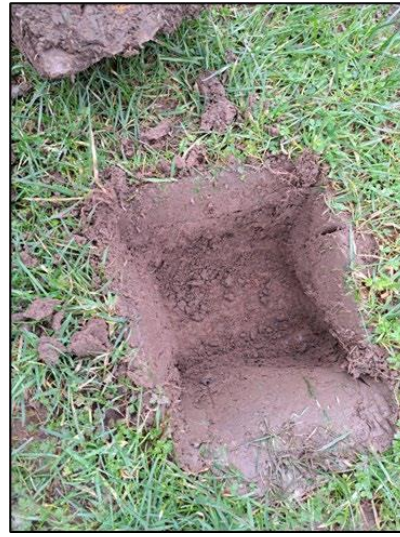
Topsoil texture was classed as a *clay loam* made up of 41% sand, 31% silt and 28% clay; the subsoil was a *stone clay loam*.

Once clay contents exceed approximately 30%, they can significantly and adversely affect the rate at which water can percolate through the profile (i.e. characterised by low hydraulic conductivity). Given that the clay content of the subsoil is 32%, it is expected that drainage rates through this material may be affected.

Figure 6 Stony subsoil – rugby pitch

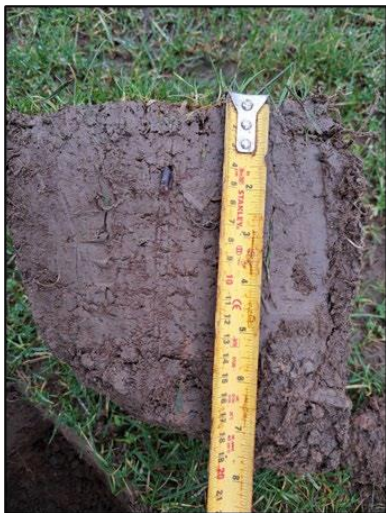
Figure 7 Soil profile –football pitch

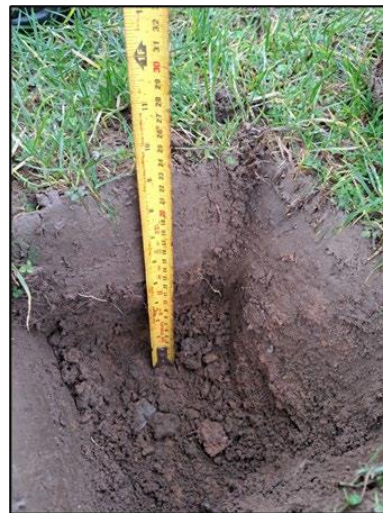
Figure 8 Stony subsoil – football pitch
